Channel Morphology and Bed Sediment Characteristics Before and After Habitat Enhancement Activities in the Uridil Property, Platte River, Nebraska, Water Years 2005–2008

Prepared in cooperation with the Platte River Whooping Crane Maintenance Trust

Open-File Report 2009-1147

By Paul J. Kinzel

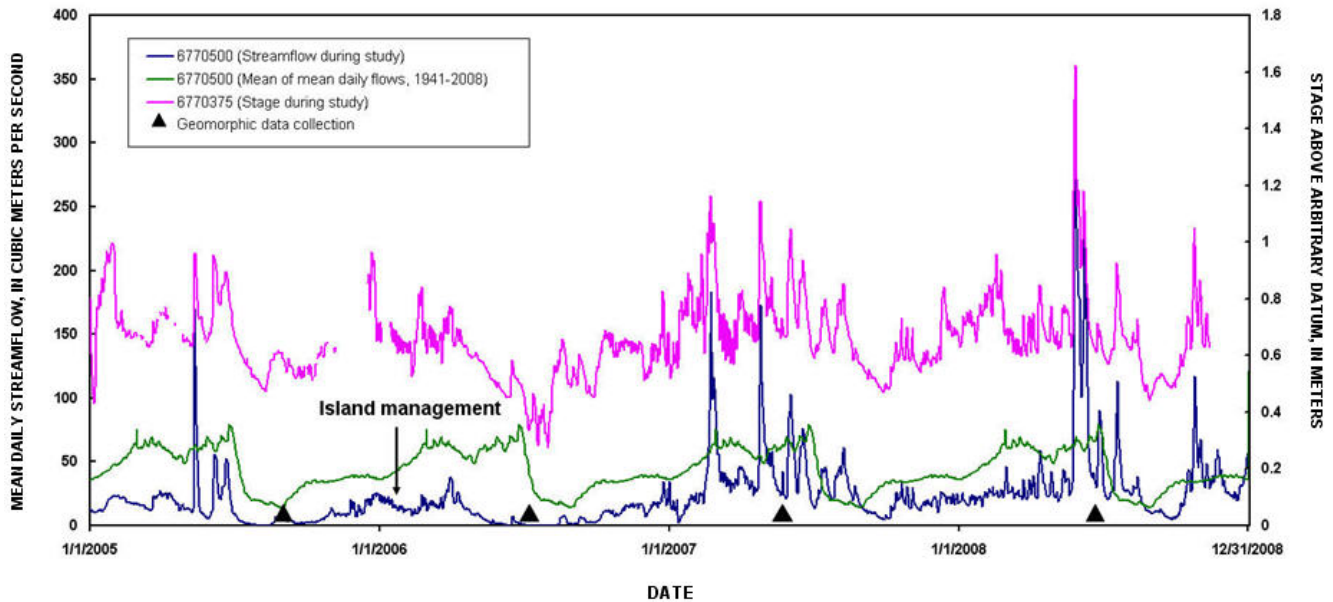
Figure 4. Hydrograph showing the mean daily streamflow during the study and the mean of the mean daily flows between 1941 to 2008 at USGS 06770500, Platte River near Grand Island, Nebr., the mean daily stage during the study at USGS 06770375, Platte River near Prosser, Nebr., and the dates of geomorphologic data collection and island management in the study reach.

Mean daily stage values recorded at this gage during the study are shown in figure 4.

In the first year of the study, July 1, 2005 to June 30, 2006, the total annual flow was approximately 22 percent of the average total annual flow from 1941 to 2008 and no major peak flows occurred. From July 1, 2006 to June 30, 2007 two major peak flows occurred, February 23, 2007 at 206 m³/s and April 26, 2007 at 183 m³/s. These magnitudes fall between peak discharges with a 2 and 5 year recurrence interval (Soenksen and others, 1999). The total annual flow in this year was 57 percent of the average total annual flow. In the final year of the study, 2007 to 2008, a flow of a larger magnitude than those observed in 2007 occurred in the study reach (fig. 4). These elevated flows were caused by rain events (Kinzel, 2008). The maximum provisional flow measured at the Grand Island gage was approximately 360 m³/s. This magnitude falls between peak discharges with a 5 and 10-year recurrence interval, 306 and 391 m³/s, respectively (Soenksen and others, 1999). The total annual flow from July 1, 2007 to June 30, 2008 was 76 percent of the average total annual flow.

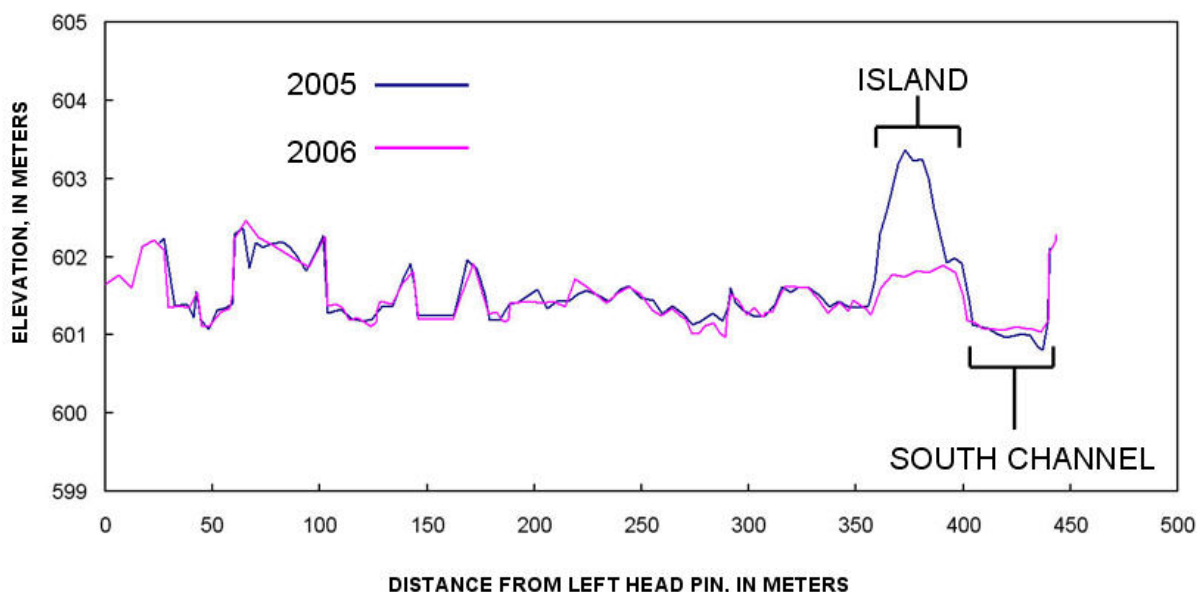
Figure 5. Topographic surveys collected along transect 14 before (2005) and after (2006) island management.

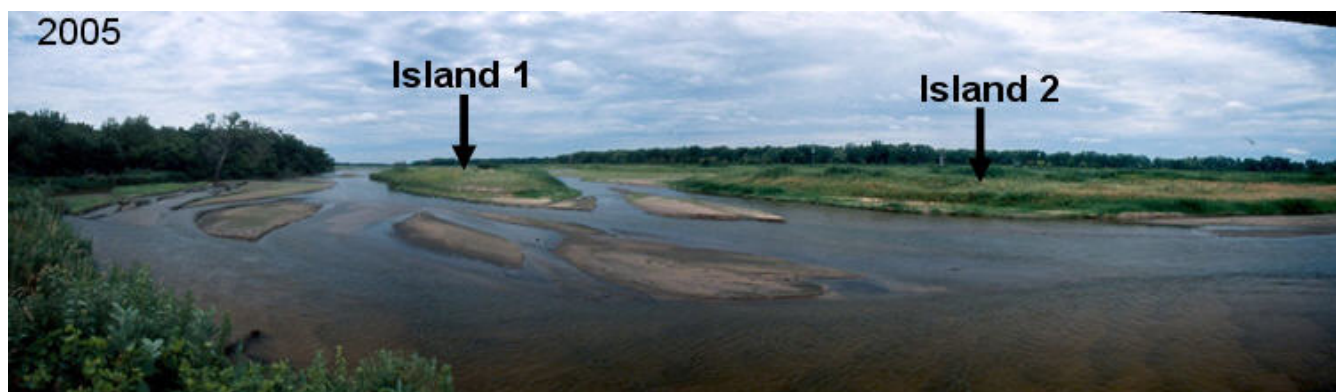
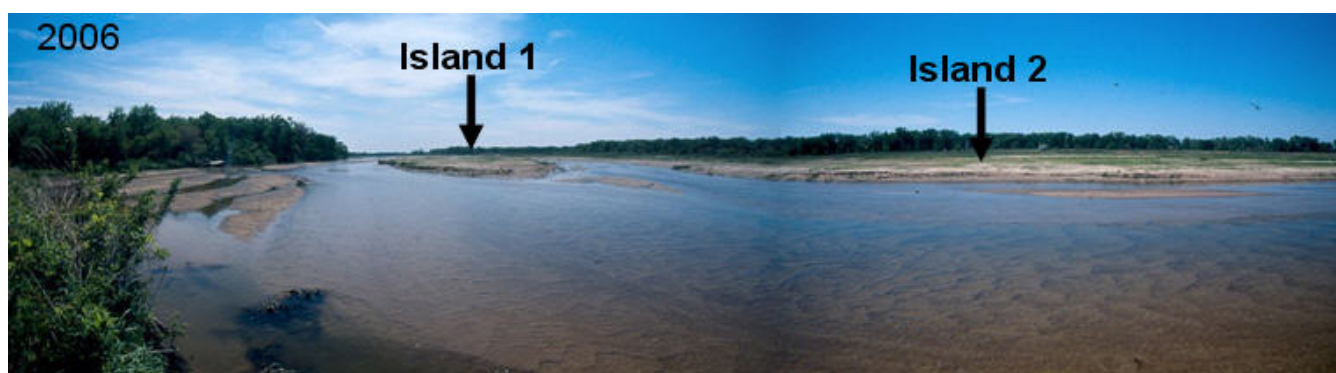
Figure 6. Panoramic images created from ground photographs taken from the right bank near transect 13. The photographs were taken looking upstream at islands 1 and 2. (*A*) Before the management activities on July 26, 2005 and (*B*) following the management activities on May 20, 2006.

digital images at a resolution of 200 dots per inch. Panorama photographs were taken from the right bank at transect 13 looking upstream at two of the three managed islands in 2005 before the management activities and in 2006 following the management activities (figs. 6*A,B*). The collection of ground photographs taken during the study period are provided in Appendix 3. The file name of each photograph indicates the year, transect number, and direction the photograph was taken. Photographs taken upstream are identified (us), along transects (xs), and downstream (ds).

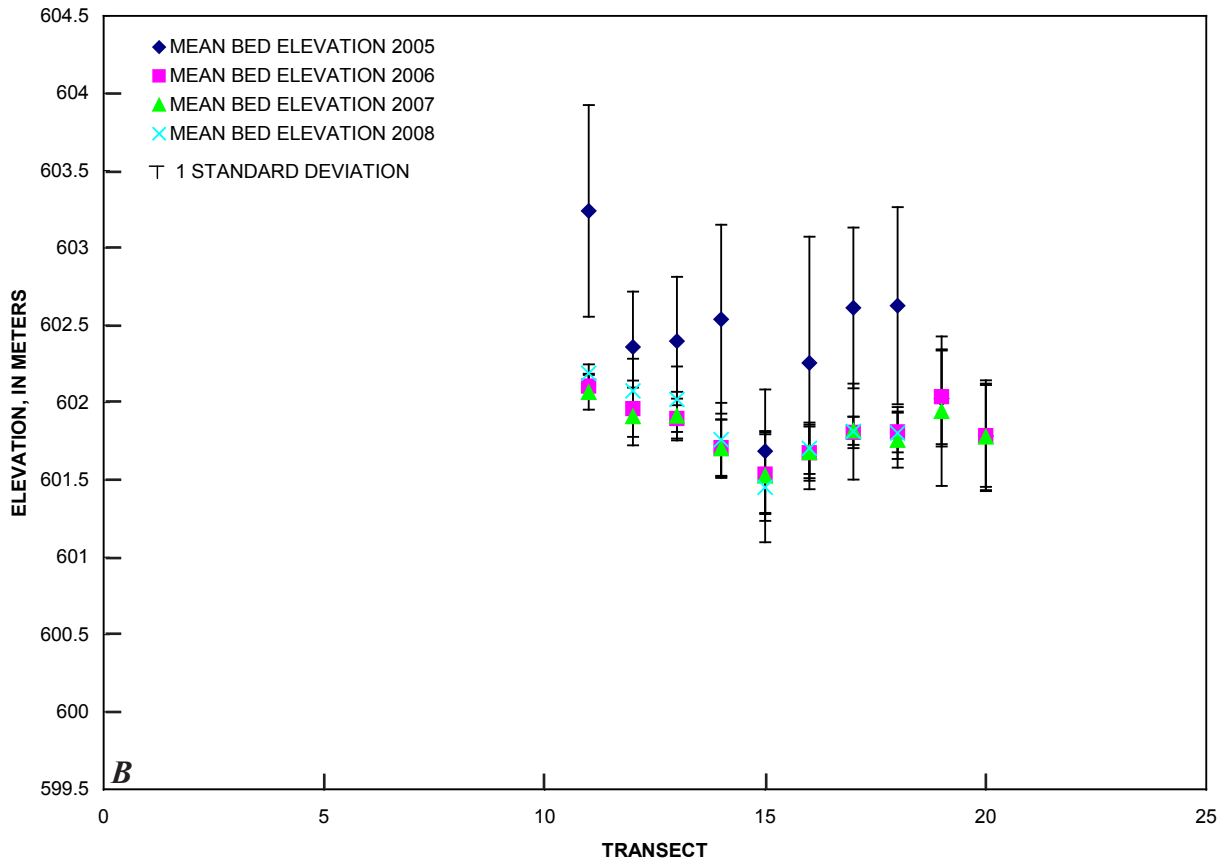
Figure 7. Longitudinal mean bed elevation upstream from, within, and downstream from the management area prior to (2005) and following the management (2006 to 2008) for (A) the entire channel, (B) the managed islands, and (C) the south channel.

Plots of mean elevations along various segments of the transects were made to illustrate the mean-bed elevations for the annual surveys and their standard deviations (fig. 7). For the annual site visits (2005 to 2008) all of the points surveyed between the left and right banks along transects 1 and 30 were used to compute a mean elevation for the transects in this reach (entire channel) (fig. 7A). In the reach of the river

between transects 11 and 20, the mean elevations on the managed islands are plotted for 2005 to 2008 (fig. 7B). The mean elevation of the points surveyed between the island and the right bank (south channel) along transects 11 through 30 are also plotted (fig. 7C). Figure 7A shows that the reach upstream of the islands (transects 1 to 10) has relatively small standard deviations and as the transects transition downstream and across the managed islands, the standard deviations increase in magnitude. The profiles shown in figure 7B indicate the change in the mean elevations on the islands as a result of the management activities. The mean elevation at transect 11 on the island decreased over 1 m from the management. However, it is the only transect with a post-management mean that falls outside the standard deviations of the pre-management measurements. The majority of transects between 11 and 23 in the south channel (13 out of 20) showed an increase in mean elevation in the surveys conducted from 2005 to 2006 (fig. 7C), which coincide with the time period of sediment addition, but these changes also fall within the standard deviations of the measurements.

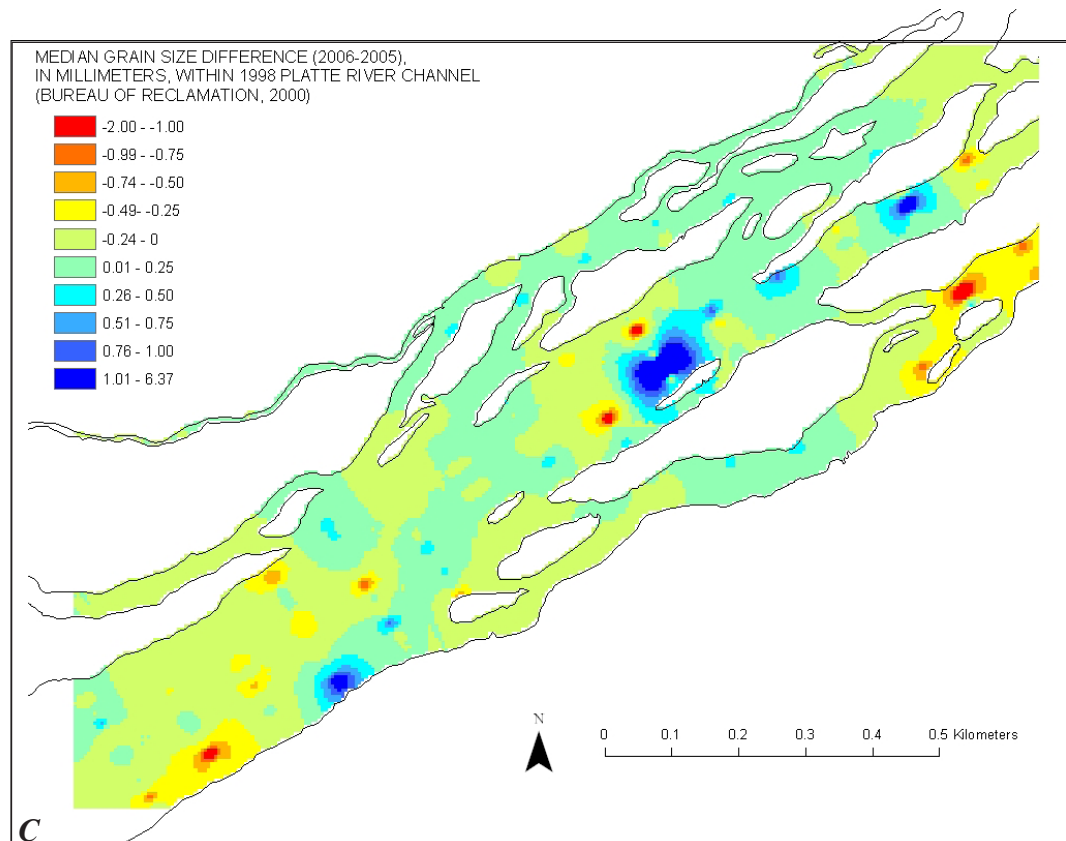
Figure 9. Interpolated median grain size (D_{50}) surface generated from river bed samples (*A*) collected July 2005 and (*B*) May 2006, and (*C*) interpolated difference in bed sediment median grain size (D_{50}) between samples collected in 2005 and those collected in 2006. The 2005 sample results were subtracted from the 2006 sample results; therefore a negative value indicates the area sampled became finer from 2005 to 2006 and a positive value indicates the area sampled became coarser.

Examination of the maps of bed-sediment median grain size, D_{50} , illustrate that there was a large range in the D_{50} parameter throughout the reach (figs. 9*a* and *b*). The mean D_{50} in 2005 across the reach was 0.69 mm with a standard deviation of 0.37 mm; those collected in 2006 had a mean of 0.68 mm with a standard deviation of 0.59 mm. Figure 9*C* illustrates the spatially interpolated differences. A small amount of fining is seen near the areas of sediment addition

(fig. 2). However, other areas in the study reach away from the augmentation underwent similar or even greater magnitudes of fining (fig. 9*C*). The samples collected on all the islands in the reach prior to the management (2005) had an average D_{50} of 0.34 mm and a standard deviation of 0.15 mm, while the samples collected on the islands that were leveled had an average D_{50} of 0.32 mm and a standard deviation of 0.12 mm. The percentage of silt and clay in the island samples ranged between 0.17 percent of the total by mass to 16.63 percent with an average of 4.58 percent and a standard deviation of 5.22 percent.
