Mormon Island Wet Meadow Restoration Report (Husker Highway & US-281/34 Mitigation;
USACE Proj. No.: NWO-2005-11444-WEH) – 11/30/2021

Project Progress Report

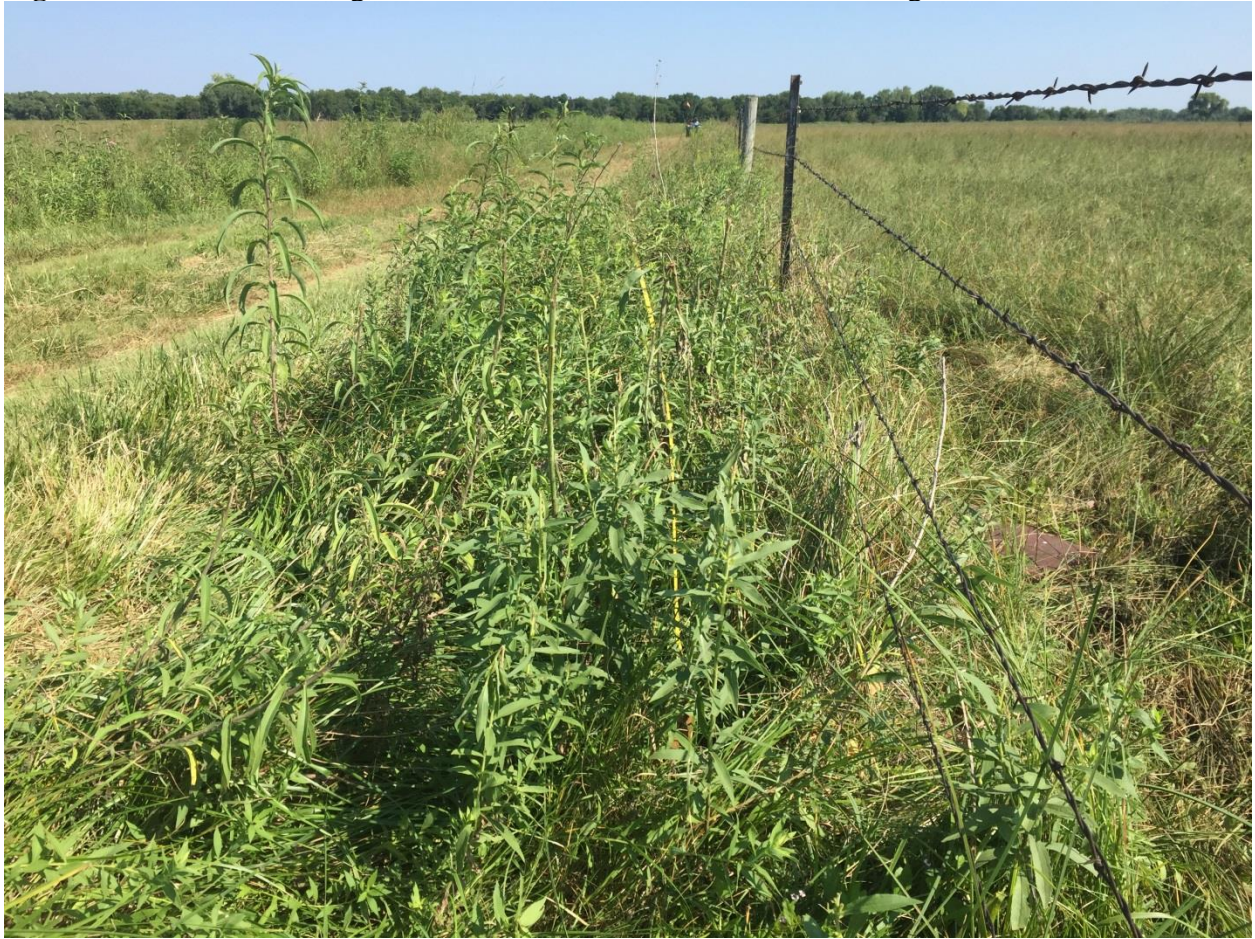
Figure 1. Photo of road targeted for wetland restoration taken on 9 August 2018.

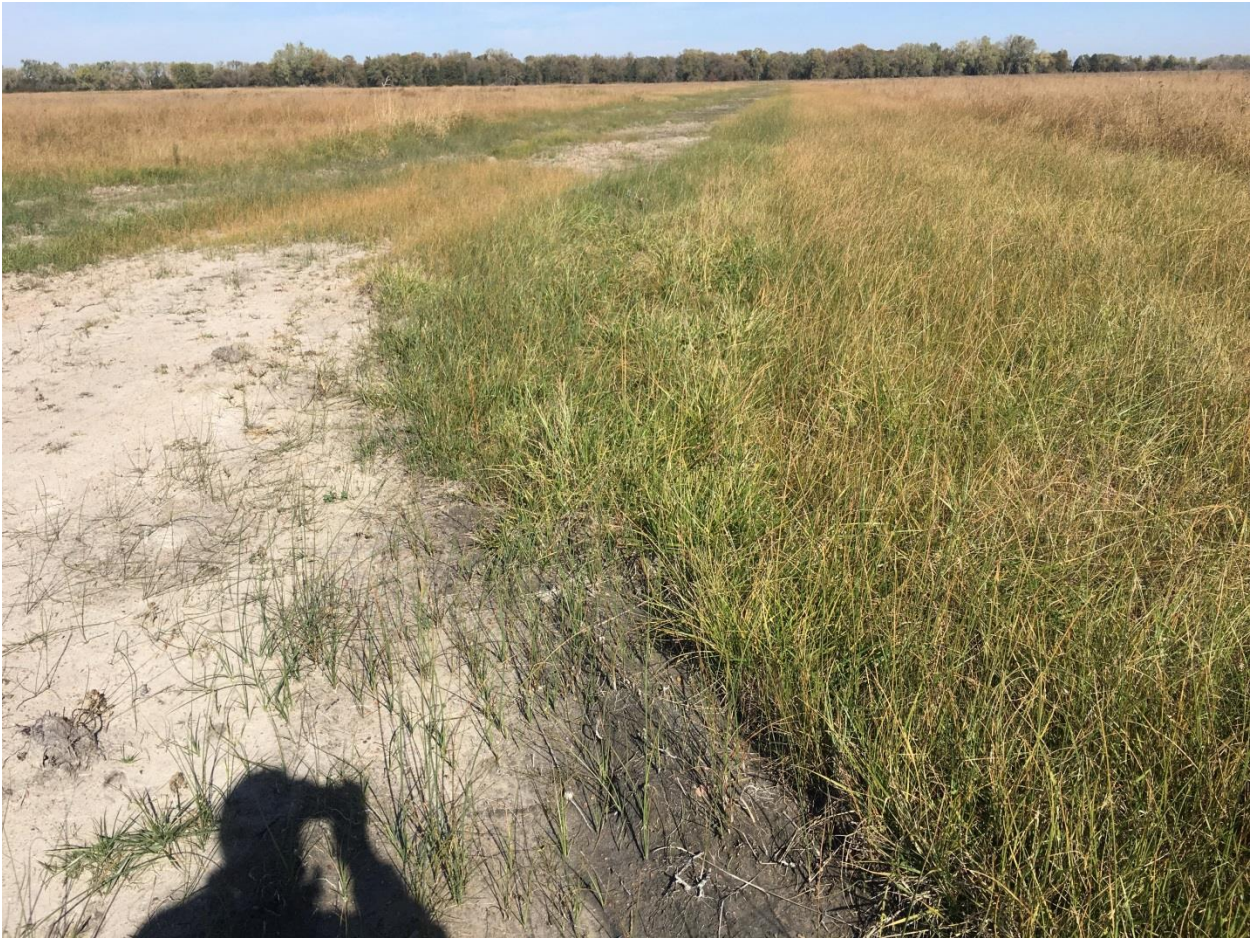
Figure 2. Photo of restoration about two months after soil work and reseeded taken on 17 October 2019.

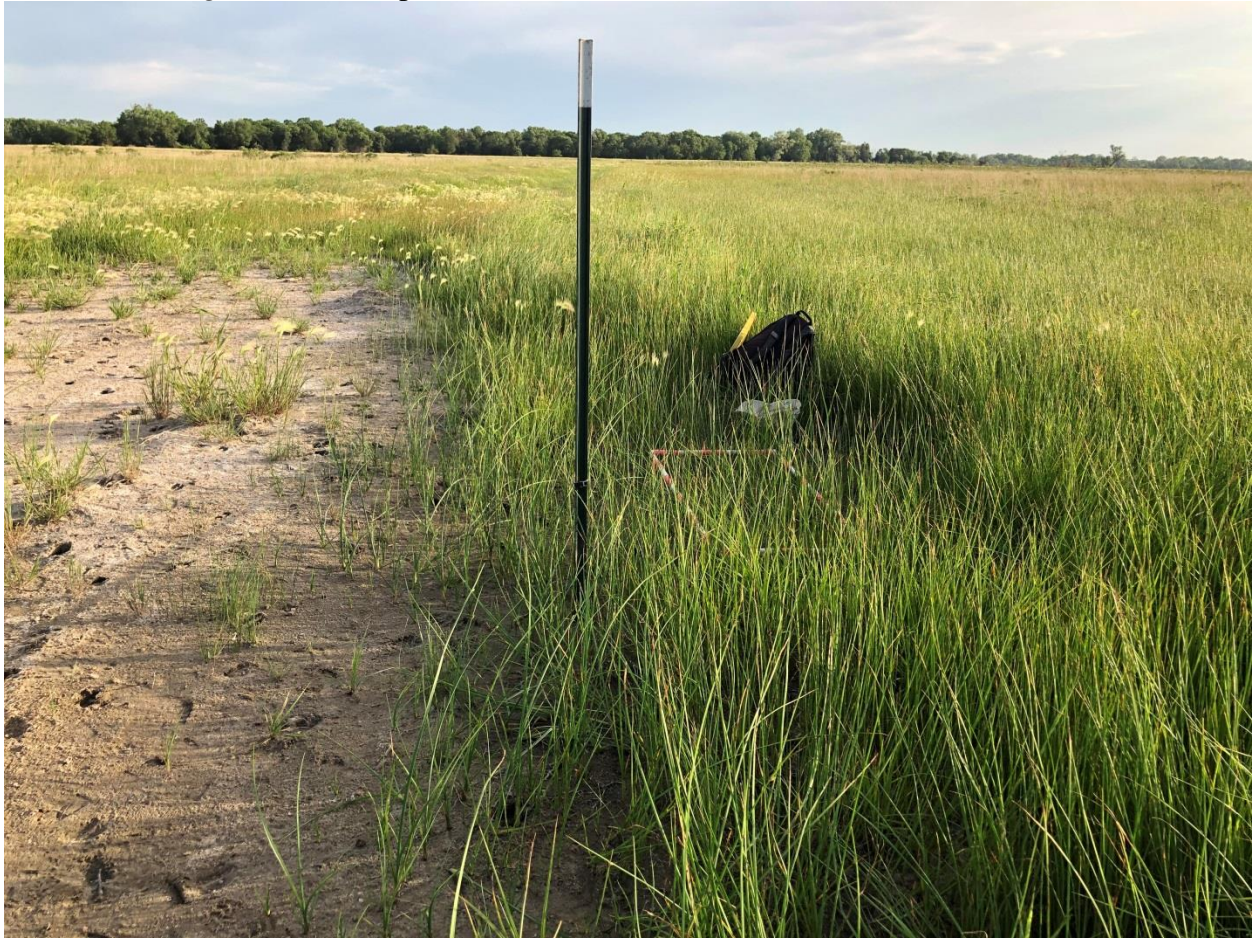
Figure 3. Photo of restoration taken on 15 June 2020 as soil and vegetation were assessed. Saturated soils with high organic content are visible from this photo where White-tailed Deer (*Odocoileus virginianus*) hoof prints are discernable in the soft substrate.

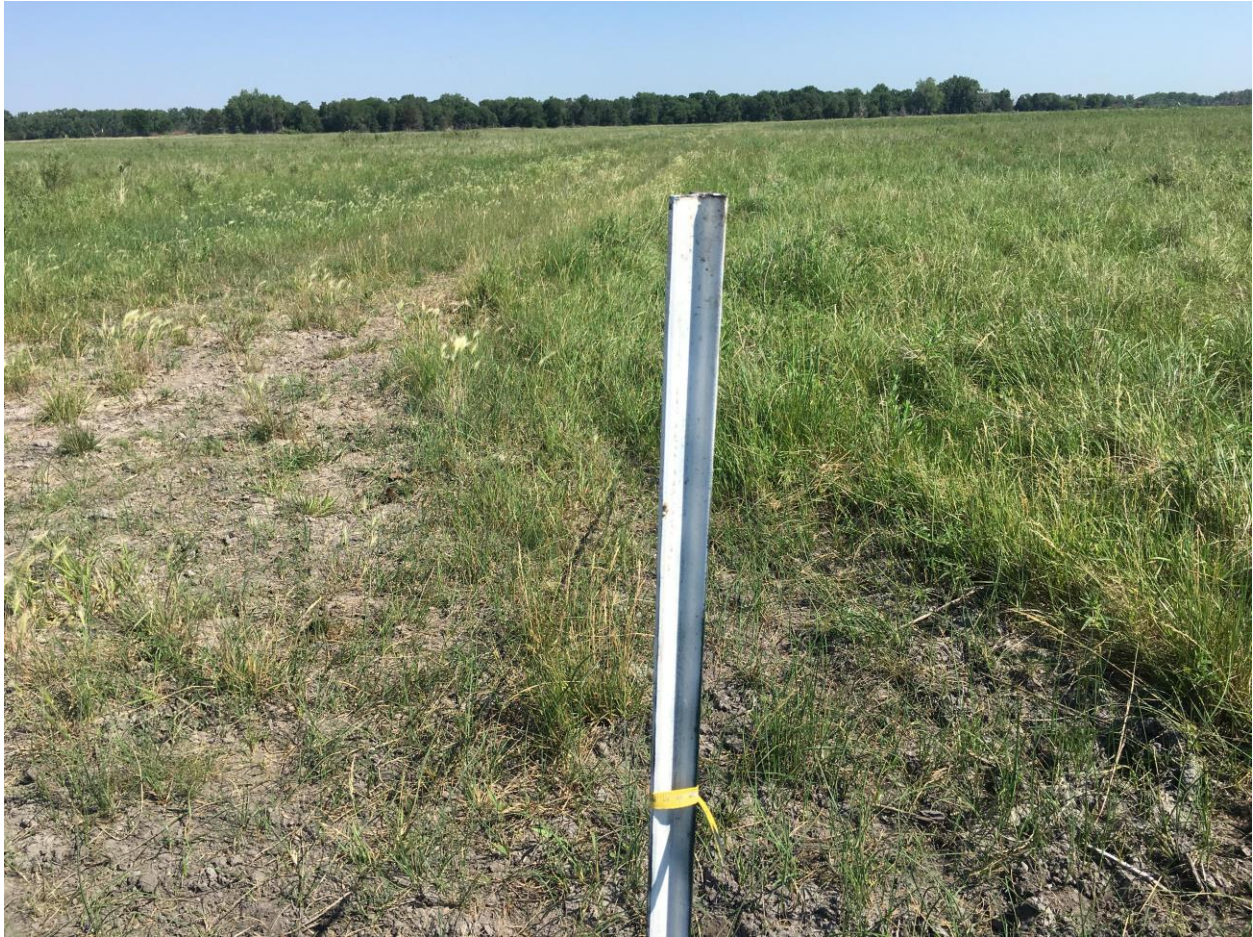
Figure 4. Photo of restoration taken on 16 June 2021 as vegetation was assessed. It is visually apparent that conditions were slightly drier at the site compared to the previous year (2020), and some bare ground has persisted within the restoration, likely because of these conditions.
